The Importance of Natural Flow of Water - Cases on various types of wetlands

Prepared for the Ramsar COP14
Compiled by Ramsar Network Japan
and Korea Wetlands NGO Network

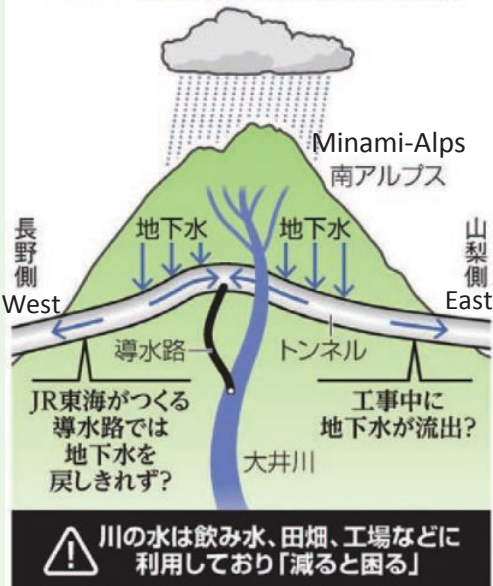
<p>Minami-Alps 南アルプス</p> <p>長野側 ← West 山梨側 East →</p> <p>地下水 地下水</p> <p>導水路 トンネル</p> <p>JR東海がつくる導水路では地下水を戻しきれず?</p> <p>大井川</p> <p>工事中に地下水が流出?</p> <p>川の水は飲み水、田畑、工場などに利用しており「減ると困る」</p>

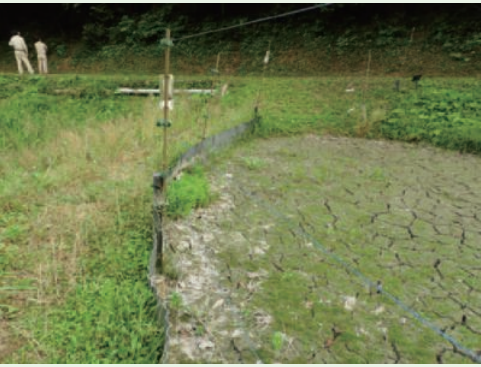
<p>Water shortage at rice paddies</p>

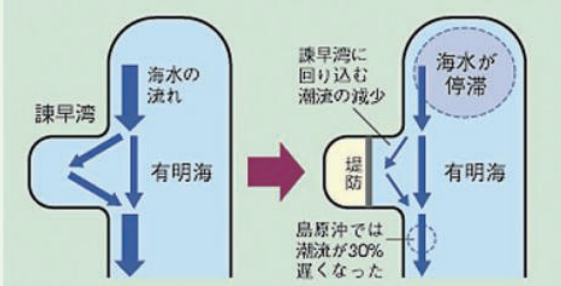
<p>(Source: http://www.isahaya-higata.net/)</p> <p>Mega sea dike slowed tidal current in Isahaya-bay and changed the tidal flow of Ariake-sea. Degradation of water quality in the reservoir.</p>
<p>Change in ecological characteristics</p>		<p>Tidal flat (2900ha) has gone Biodiversity dependent on tidal flat has gone. Change of tidal flow of Ariake-sea causes a big red-tide on the surface and mass poor oxygen in depth. Fishery(include seaweed and shellfish) damaged badly.</p>
<p>Pictures</p>

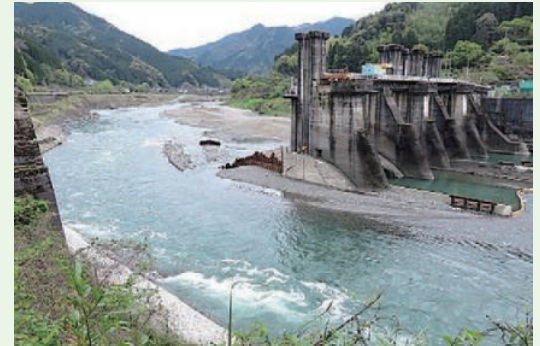
half removed

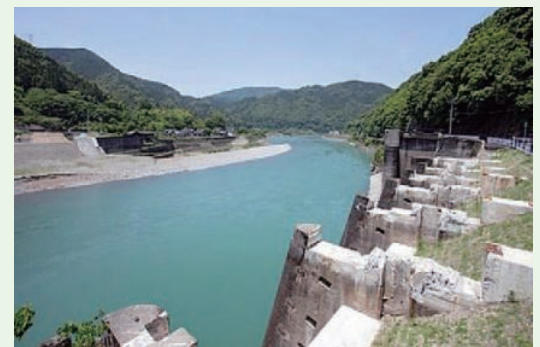
fully removed
