Earthquake in Pakistan

An Assessment of Environmental Risks and Needs

Based on IUCN Field Missions to NWFP and AJK
November 19–26 and December 4–7, 2005

January 16, 2006

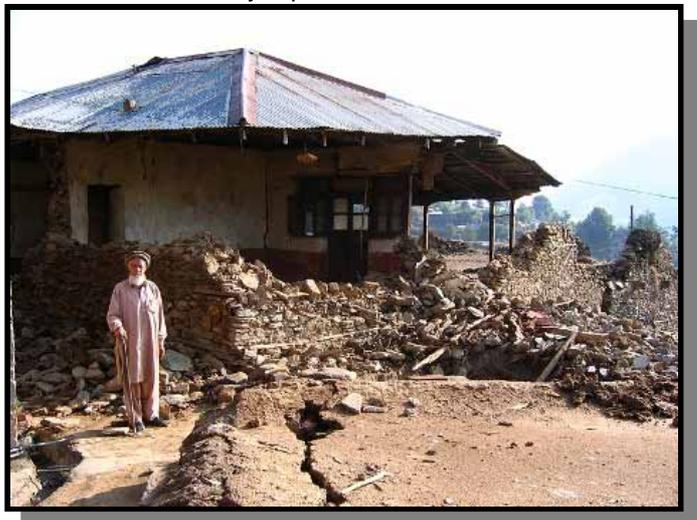
Huge losses in life and property were reported in the areas of NWFP which were visited. Landslides have occurred at many locations in the hilly areas. Most of these slides had not stabilized at the time the mission was fielded, as was especially observed in *Allai*, where the soil was still unsettled due to continued tremors.

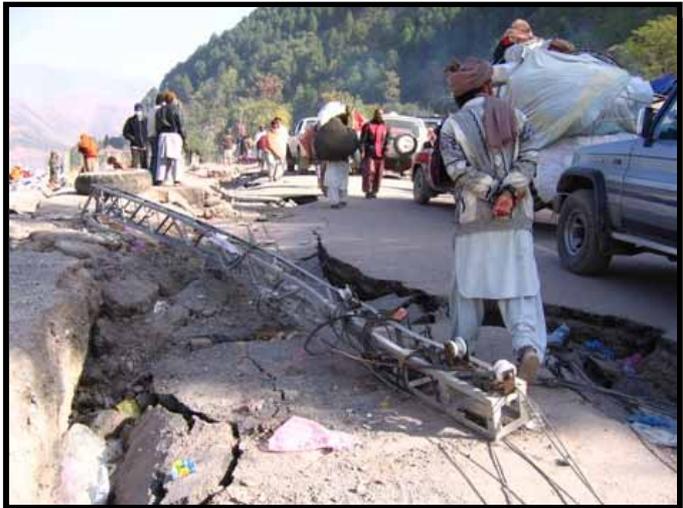
The basic damage to the physical environment in AJK was due to the massive landslides, throughout the affected areas. Their occurrence was the highest in and around the area of epicentre, *Muzaffarabad* and its environs. The slides

have caused huge damages to the infrastructure of the area, such as to roads, bridges, houses, public structures, and even heritage sites, such as the *Muzaffarabad* Fort. In most areas these slides have not yet stabilized.

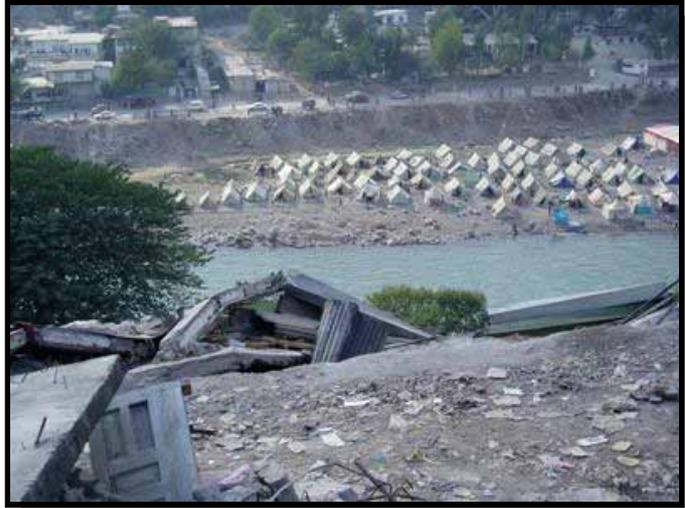
Flash Floods: Landslides caused by the earthquake have temporarily blocked several rivers. This kind of river blockage risks causing flash floods once the dam breaches. As more landslides are expected, the risk of flash floods is not over. Therefore people should avoid to camp or stay close to the river beds.

In the *Muzaffarabad* district, en-route to *Bagh*, in the *Hattian Bala/Chakaar* area, a massive landslide

has blocked the river of a side valley of the *Jehlum* River. The dam created by the landslide may be as high as 150 to 250 meters. Behind this dam a lake is slowly being formed, inundating the communities residing there. It will take months or even years to fill this lake. However, once the lake is full, there is a risk that the dam, created out of non-consolidated landslide rubble, may breach. A landslide into the lake could create a big wave that can destabilize the dam. If the dam gives in, it could cause a catastrophic flash flood, which would sweep away communities and cities downstream, along the *Jehlum* Valley down to the plains of Punjab.

The risk of this dam is such that it has to be assessed by most qualified experts. Large scale engineering works to reduce the maximum level of the lake, as much as possible, will probably have to be undertaken.

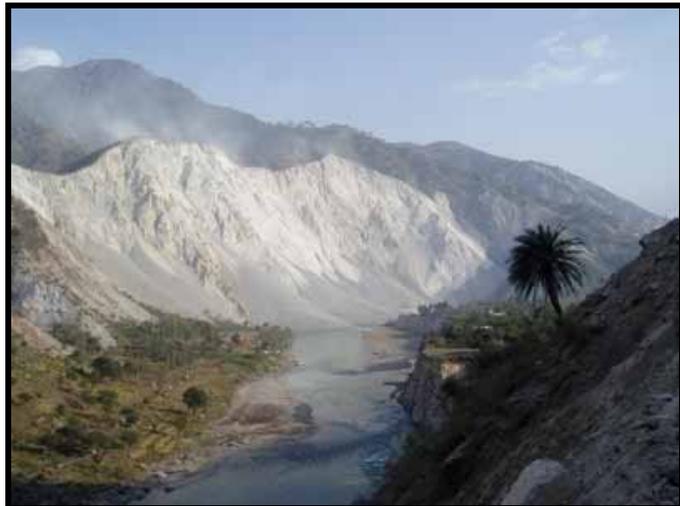
Silt Load in rivers: The rivers in the affected areas have received large volumes of sand, soil and stones from the landslides that occurred as an immediate consequence of the EQ. This has significantly raised the silt load in these water bodies, which will be transported downstream. This may not be apparent at the moment, and the material deposited in the water bodies may appear to have settled at present, mainly due to the low flow in the rivers.

However, as the volume of water in the rivers increases after rains, this silt may dislodge and be carried downstream. This will increase the rate of siltation of the *Mangla* reservoir, located near the town of *Jehlum* in Punjab further downstream on the River *Jehlum*.

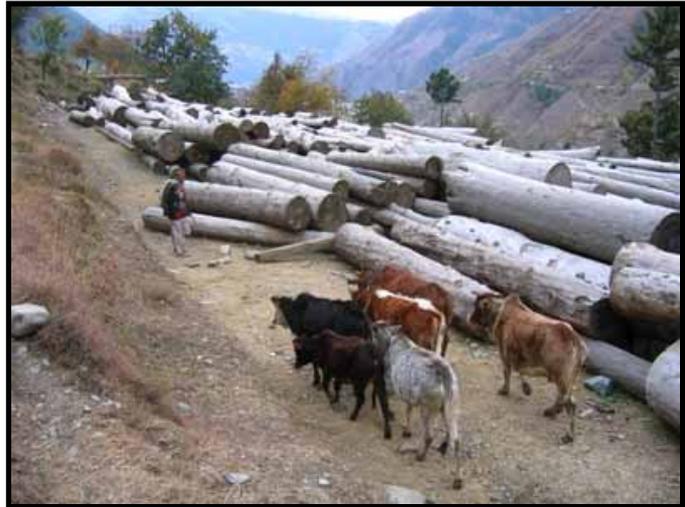
Damages to Trees and Forests: In the core area of the earthquake, standing forests on steep slopes were destroyed by landslides. Furthermore, many trees were damaged by rock falls. The earth shaking during the EQ was such that some trees simply truncated about two meters above the ground. The inner structure of many trees may have been damaged which would affect their use in future.

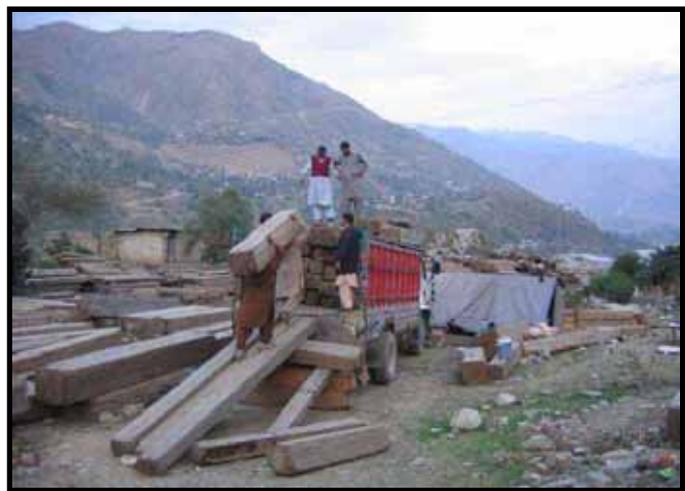
Another observation was made which also adds to the above, already high, risk. The timber stored in the affected areas is being transported out at an alarming rate for sale in high price markets in the lowlands. The Coordinating Officer in *Allai*, Col. Zakeer has placed a ban on the movement of timber out of the valley to reduce the need for cutting of trees for construction and other purposes.

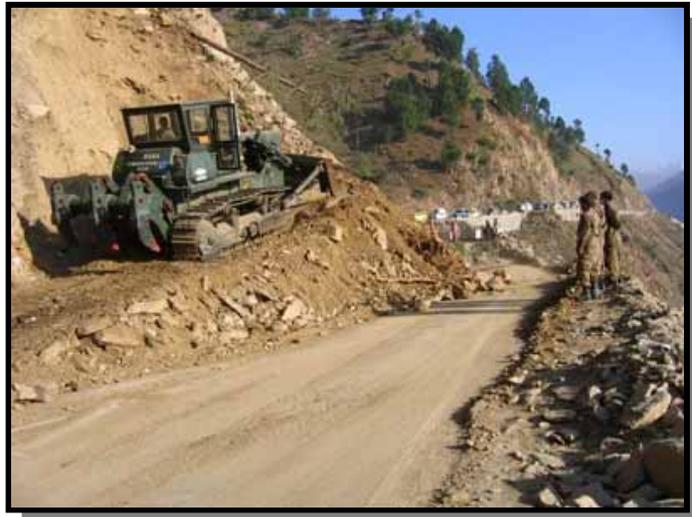
Roads: Due to the devastating EQ, many roads have been destroyed in the mountain areas of AJK and NWFP. The army did a great job in quickly repairing the main roads. Still, there are many link roads which have not been repaired, and it is difficult for the people living there to get the necessary relief items and material for reconstruction of their shelters and houses. The winter, with snow and rain and more landslides and mudslides, will again close many of these roads.

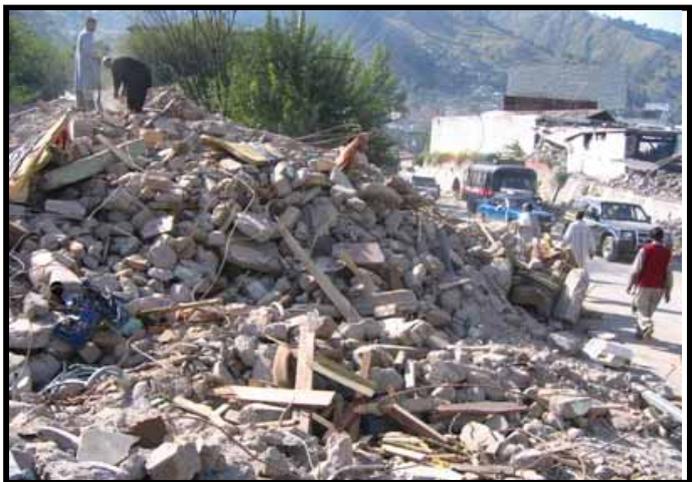
Debris removal: A major environmental challenge, mainly in the affected urban areas, is that of proper removal of the debris of collapsed buildings. Part of the debris need to be separated and used for reconstruction. The rest has to be removed to proper dumping sites. If the rubble is dumped anywhere without considering the topography, hydrology and drainage patterns of the area, it is likely that this would have adverse effects on the overall hydrology of the area.

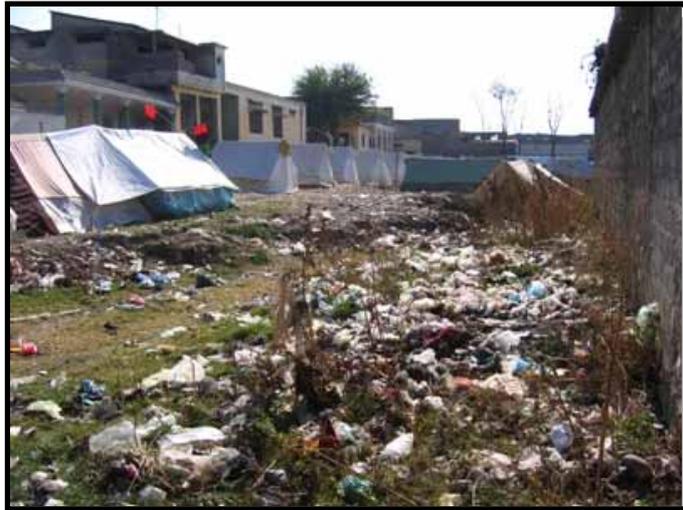
- **Waste management:** Solid and liquid waste management, was, most of the time, not adequate, even before the earthquake. The rudimentary waste management systems, where they existed, have collapsed. The relief operations have added to the amount of waste accumulated in the areas. There are three types of wastes being generated in the relief camps 1) **aid waste**, which was seen scattered all over during the first mission but had almost disappeared by the time of the second mission, 2) **domestic waste**, generated by camp operations such as kitchen waste and other related waste, and 3) **medical waste**, from field hospitals which at some camps is being managed adequately, but mostly being just mixed with domestic waste creating potential serious health hazards.

The most serious problem is the management of medical care waste. Waste management was not a priority during the first weeks of relief operations. Except in some well managed larger camp sites, waste mismanagement is rampant; if this issue is not addressed effectively, it will cause more problems and lead to diseases, even epidemics.

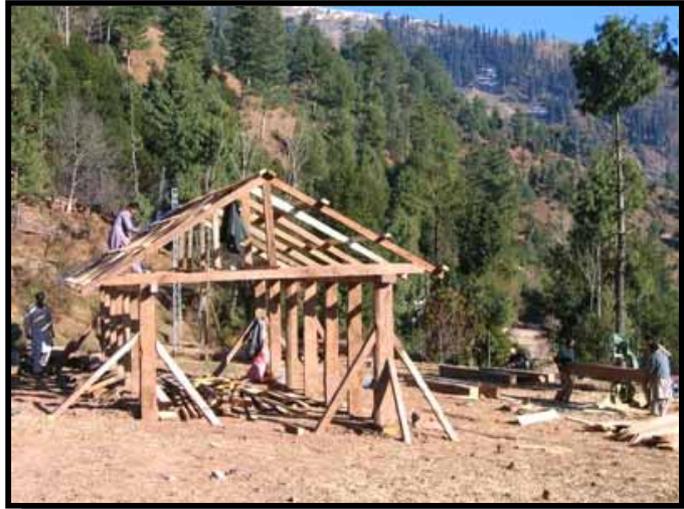
This would be an important area to reduce the burden on forests for timber and fuel wood. There is a good potential of reuse and recycling of wood and other construction material present in destroyed buildings.

There is a need to improve traditional housing structures by making them safer and environment friendly. Timber intensive construction should be replaced by more appropriate designs with

utilization of timber alternates. Insulation in the houses needs to be improved. More use of CGI sheets may be a viable option.
